**Flood Control Project Maintenance
Levee Inspections**

Maintenance Issue Types Only, Levee Inspection Report By Mile - Spring 2018

Reclamation District No. 2085 Kasson

Waterway	Bank	Unit Miles	Inspection Start/End	Inspector
Unit No. 01 San Joaquin River	Left	5.29	03/09/2018 03/09/2018	Maksim Khashchuk

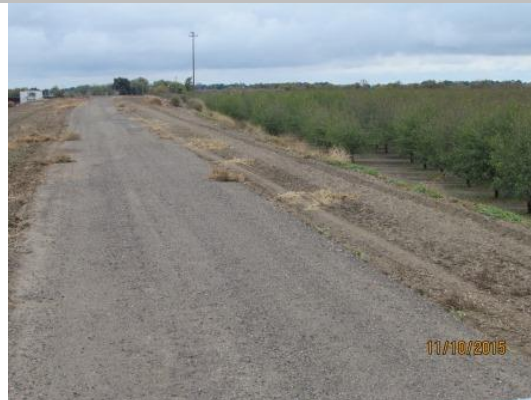
Photo 1 of 1 : SP_2018_RD2085_113_19_20180305_00016.jpg

LM Start	0.12	Rating **	A/W	Issue No.	19
LM End	0.47	Issue Type +	Ma	Location *	CR
Category	Earthen Levee			GPS Latitude/Longitude	
				Start	End
Item	Crown Surface / Depressions / Rutting			37.719052 °	37.723246 °
				-121.302928 °	-121.299492 °
DWR ID	DWR_RD2085_01_f_2015_19				
Comment Code					
C1 : Add appropriate material and re-grade the levee to bring the crown above the design elevation.					
Inspector Comment					
Disking on the levee shoulder. Make sure the water drains evenly to the slopes.

View of the disking on the levee crown shoulder.

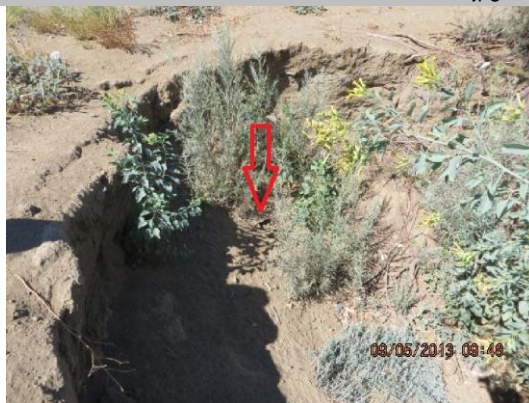
Photo 1 of 3 : UCIP_SP_2018_52493_62262.jpg

FS_ID:52493
DS_ID:20677
EP_NO: N/A
Repair Type: No Action Needed
Crossing Status: Found
UCIP Comments: Pipe has been removed by LMA. Previous: Pipe abandoned. Erosion around pipe on WS slope. Pipe severely corroded. Pier badly damaged.
FIELD_STRUCT_DESC: *REMOVED* 14-inch steel drainage pipe through the levee, 4.5 feet below the crown. Pump on pile structure in ditch on the landside (LS). Siphon breaker in corrugated metal pipe (CMP) riser on the waterside (WS) shoulder. Pipe removed by LMA. (Permit Application No. T2013179, 2014 - Surinder Sandhu, submitted to CVFPB. Permit was not needed per CVFPB review). [Additional Reference(s): DWR Levee Log, 2005. USACE San Joaquin O&M Manual 11, 1968, (HLM 0.47)].
FS Date: 9/5/2013

(Pipe removed by LMA) Pipe on WS with erosion into levee slope.

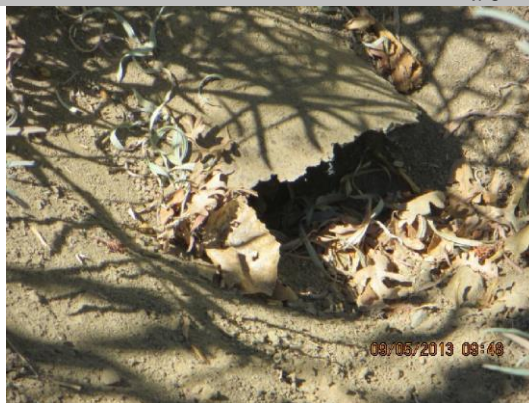
Photo 2 of 3 : UCIP_SP_2018_52493_62261.jpg

Pipe removed from WS toe.

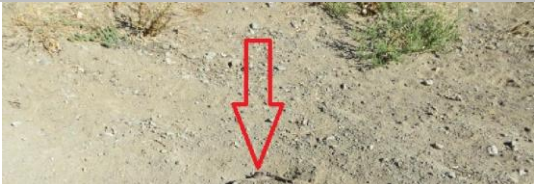
Photo 3 of 3 : UCIP_SP_2018_52493_62260.jpg

Siphon breaker in 24-inch CMP riser on WS shoulder was removed by LMA.

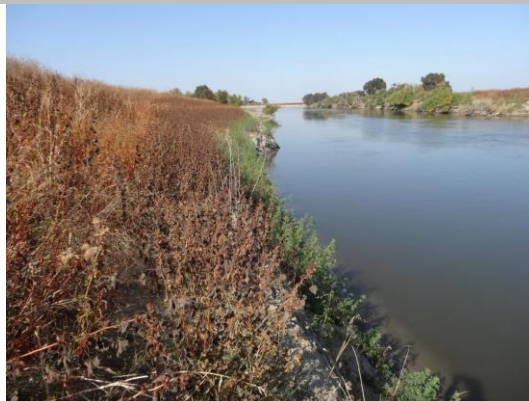
Photo 2 of 4 : SP_2018_RD2085_113_1_20180305_00002.jpg

Looking downstream at the erosion site.

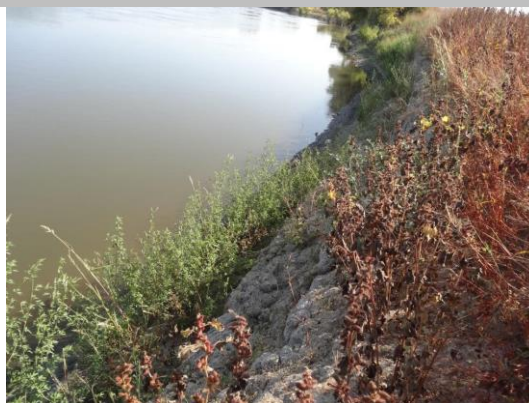
Photo 3 of 4 : SP_2018_RD2085_113_1_20180305_00003.jpg

Close view of the erosion.

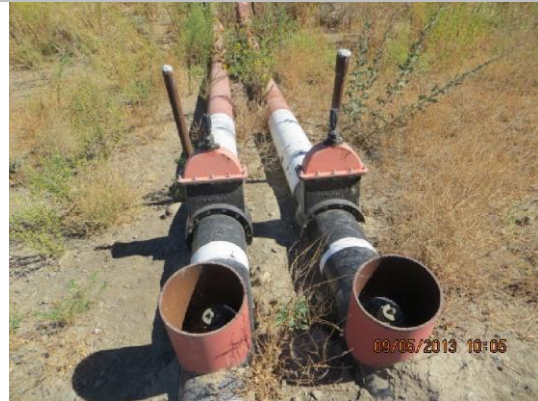
Photo 3 of 3 : UCIP_SP_2018_19384_32926.jpg

LM Start	1.35	Rating **	A/W	Issue No.	53 (cont)	
LM End	1.35	Issue Type +	Ma	Location *		
Category	Supplemental			GPS Latitude/Longitude		
				Start	End	
Item	DWR UCIP LMA Responsibility			37.714409 °	37.714409 °	
				-121.289479 °	-121.289479 °	
DWR ID						
Comment Code						
Inspector Comment						
FS_ID:19384 DS_ID:20678 EP_NO: N/A Repair Type: No Action Needed Crossing Status: Found UCIP Comments: FIELD_STRUCT_DESC: 12-inch steel drainage pipe through the levee, 3 feet below the crown. Pump mounted on pile structure in ditch on the landside (LS). Steel walkway with handrails to the pump structure. Gate valve and siphon breaker in a 12-inch steel riser on the waterside (WS) shoulder. (Permit No. 8189, 1972 - Reclamation District No. 2085). [Additional Reference(s): DWR Levee Log, 2005. USACE San Joaquin O&M Manual 11, 1968, (HLM 1.28)]. FS Date: 9/5/2013

Pipe, siphon breaker, and gate valve on WS slope.

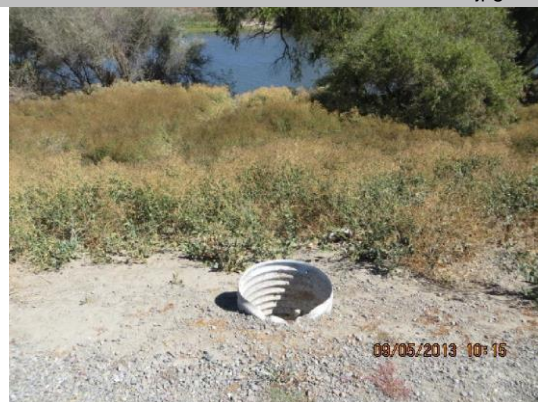
Photo 1 of 3 : UCIP_SP_2018_41351_62268.jpg

Comment Code					
Inspector Comment					
FS_ID:41351 DS_ID:20679 EP_NO: 3975 Repair Type: Non-Urgent Crossing Status: Found UCIP Comments: Pipe abandoned and should be done so properly. Large hole in ground over pipe on WS berm. Pipe rusted through on WS at river bank. No connection to pump on LS toe. FIELD_STRUCT_DESC: *ABANDONED* 10-inch steel drainage pipe through the levee, 4 feet below the crown. Steel plate over pipe end at pump station on the landside (LS) toe. Siphon breaker in a 24-inch corrugated metal pipe (CMP) riser on the waterside (WS) shoulder. (Permit No. 3975, 1962 - Glenn West Trust). [Additional Reference(s): DWR Levee Log, 2005. USACE San Joaquin O&M Manual 11, 1968, (HLM 1.35)]. FS Date: 9/5/2013

Siphon breaker in 24-inch CMP riser on WS shoulder.

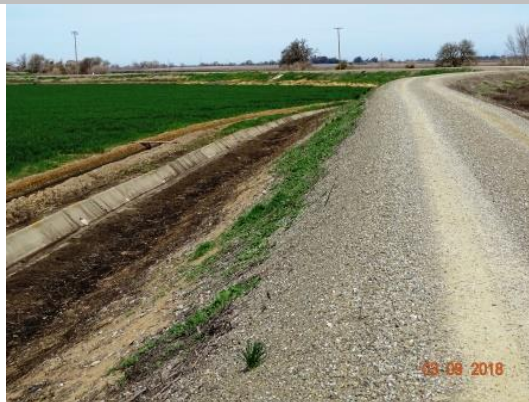
Photo 1 of 1 : SP_2018_RD2085_113_35_20180309_00074.jpg

LM Start	2.37	Rating **	A	Issue No.	35
LM End	2.37	Issue Type +	Ma	Location *	LS
Category	Earthen Levee			GPS Latitude/Longitude	
				Start	End
Item	Vegetation			37.705775 °	37.705775 °
				-121.275268 °	-121.275268 °
DWR ID	DWR_RD2085_01_s_2018_35				
Comment Code					
V1 : Control annual grass and weeds on the levee slopes and easements.					
Inspector Comment					
Acceptable vegetation control.

View of the acceptable vegetation on the levee slope.

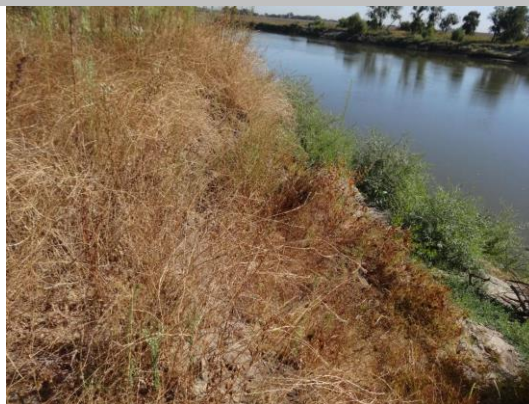
Photo 1 of 4 : SP_2018_RD2085_113_2_20180305_00005.jpg

10/04/2017: The erosion has progressed significantly toward the levee toe.
 07/08/2016: No significant change observed.
 09/10/2015: No significant change observed. Signs of animal activity are present.
 09/10/2014: No significant change observed.
 09/20/2013: No significant change in erosion observed. More vegetation at the site.
 12/04/2012: The erosion has progressed remarkably toward levee, extended to the up-and downstream of the original pocket erosion. Trees and dense bush are present at the site. Animal burrow holes are visible, and possibly can cause seepage.
 09/22/2010: No significant change observed. There is little visibility due to seasonal grass on the berm and slope.
 08/18/2009: Site is located on berm; pocket erosion has developed; the site is covered in dense vegetation; there are several relief wells on the landside of the levee; site is Not Rated because berm width is greater than 30 feet; site should be monitored to keep track of erosion progress. [2017 Site ID:RD2085U01RM66.5]

Close view of the erosion. Note the dense vegetation at the site.

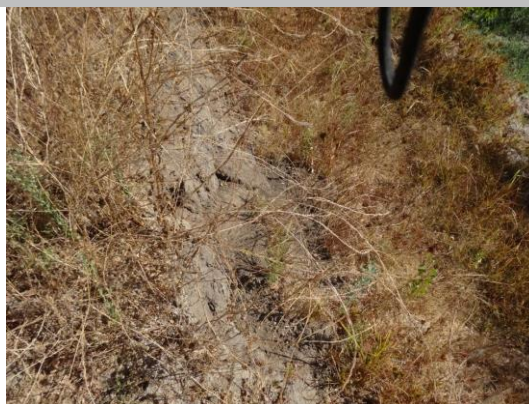
Photo 2 of 4 : SP_2018_RD2085_113_2_20180305_00006.jpg

Close view of the erosion.

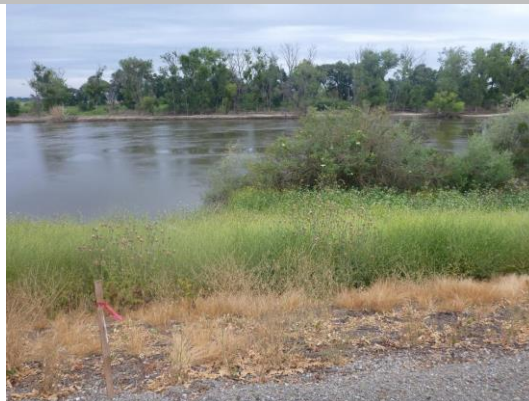
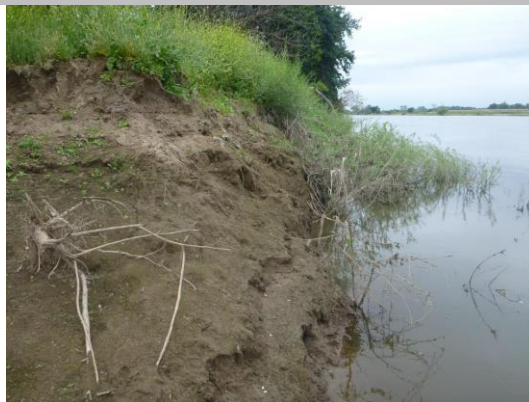
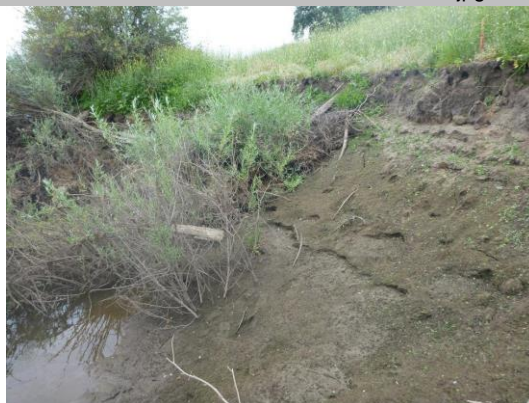
LM Start	2.57	Rating **	A/W	Issue No.	48	
LM End		Issue Type +	Ma	Location *		
Category	Supplemental			GPS Latitude/Longitude		
				Start	End	
Item	2017 Storm Damage			37.703094 °		°
				-121.274894 °		°
DWR ID	DWR_RD2085_01_f_2017_48					
Comment Code						
Inspector Comment						
Levee Evaluation Comments						
Description:						
Site ID No:105						
Site Designation:FSRP-13-55						
Repair Type: Erosion						
Rating:Serious						
Field Date:6/8/2017						
Notes:

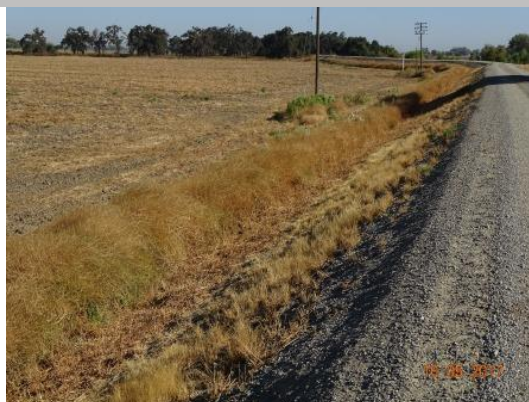
Photo 1 of 1 : SP_2018_RD2085_113_4_20180305_00010.jpg

LM Start	2.62	Rating **	M	Issue No.	4
LM End	2.94	Issue Type +	Ma	Location *	LS
Category	Earthen Levee			GPS Latitude/Longitude	
				Start	End
Item	Vegetation			37.702340 °	37.698192 °
				-121.275081 °	-121.277673 °
DWR ID	DWR_RD2085_01_f_2017_4				
Comment Code					
V1 : Control annual grass and weeds on the levee slopes and easements.					
Inspector Comment					
Vegetation at the toe limits visibility.

View of the vegetation at the levee toe.

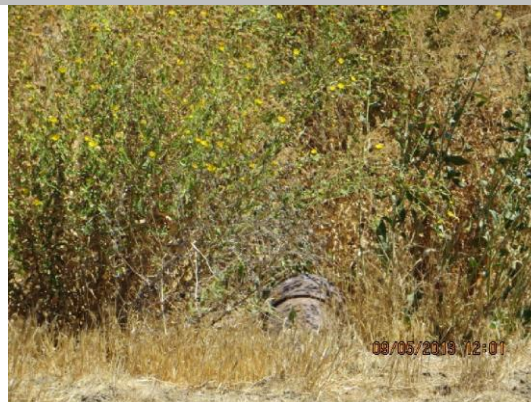
Photo 2 of 3 : UCIP_SP_2018_19433_32989.jpg

Pipe visible on WS slope.

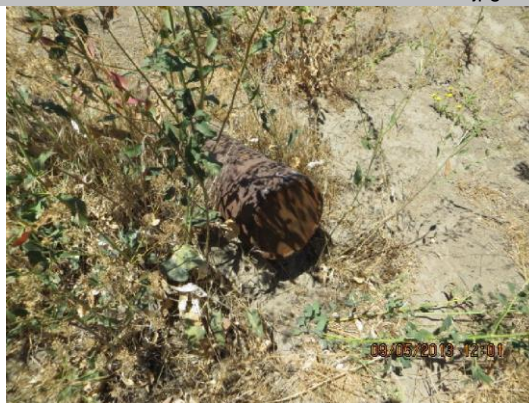
Photo 3 of 3 : UCIP_SP_2018_19433_32988.jpg

Pipe visible on WS slope. Steel plate welded over end.

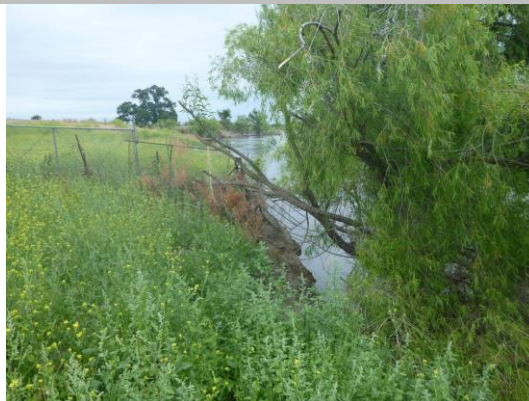
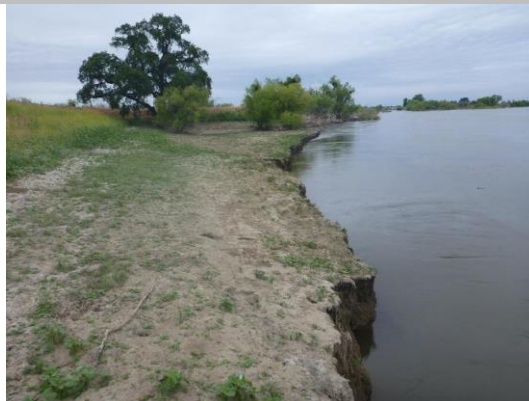
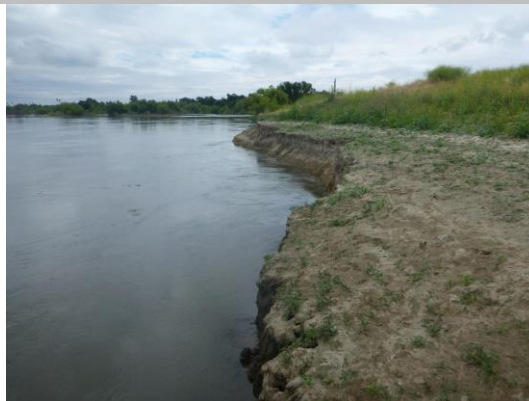
LM Start	3.68	Rating **	A/W	Issue No.	51
LM End	3.82	Issue Type +	Ma	Location *	
Category	Supplemental		GPS Latitude/Longitude		
			Start	End	
Item	2017 Storm Damage		37.688570 °	37.686620 °	
			-121.276450 °	-121.276790 °

Repair Type: Erosion

Notes: Adjusted starting and ending points for this site. Site has been repaired.

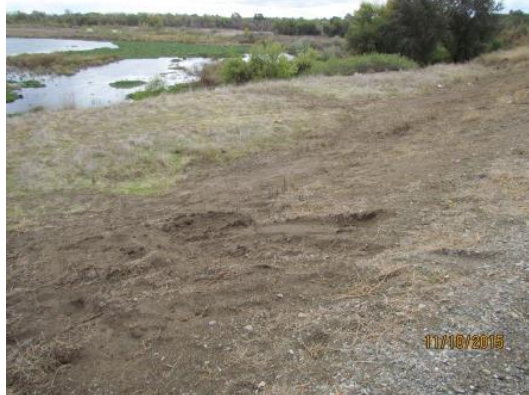
Photo 1 of 1 : SP_2018_RD2085_113_25_20180305_00018.jpg

LM Start	3.71	Rating **	A/W	Issue No.	25
LM End	3.71	Issue Type +	Ma	Location *	WS
Category	Earthen Levee			GPS Latitude/Longitude	
				Start	End
Item	Slope Stability			37.688216 °	37.688216 °
				-121.276603 °	-121.276603 °
DWR ID	DWR_RD2085_01_f_2015_25				
Comment Code					
S3 : Repair the levee slope damaged by vehicle traffic and prevent access where possible.					
Inspector Comment					
Control levee access to prevent damage to levee slopes by vehicle.

View of the waterside levee slope damaged by vehicle.

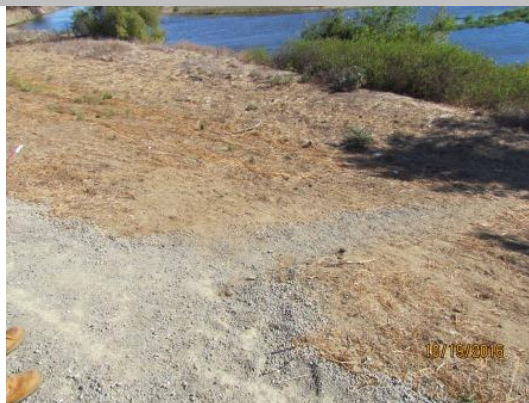
Photo 1 of 1 : SP_2018_RD2085_113_26_20180305_00019.jpg

LM Start	3.74	Rating **	A/W	Issue No.	26
LM End	3.74	Issue Type +	Ma	Location *	WS
Category	Earthen Levee			GPS Latitude/Longitude	
				Start	End
Item	Slope Stability			37.687841 °	37.687841 °
				-121.276678 °	-121.276678 °
DWR ID	DWR_RD2085_01_f_2015_26				
Comment Code					
S2 : Repair the levee slope damaged by foot traffic and prevent access where possible.					
Inspector Comment					
Area should be maintained to prevent further levee damage.

View of the foot path on the levee slope.

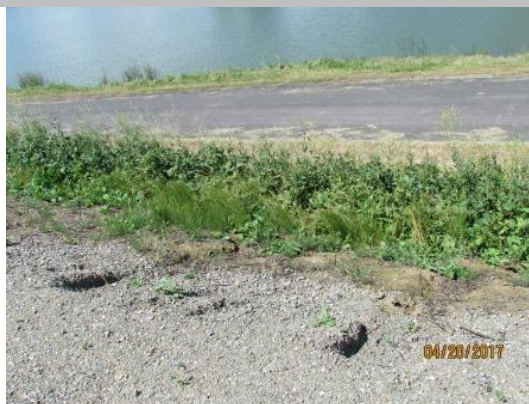
Photo 1 of 1 : SP_2018_RD2085_113_46_20180305_00031.jpg

LM Start	3.78	Rating **	M	Issue No.	46
LM End	3.78	Issue Type +	Ma	Location *	LS
Category	Earthen Levee			GPS Latitude/Longitude	
				Start	End
Item	Slope Stability			37.687253 °	37.687253 °
				-121.276780 °	-121.276780 °
DWR ID	DWR_RD2085_01_s_2016_46				
Comment Code					
S3 : Repair the levee slope damaged by vehicle traffic and prevent access where possible.					
Inspector Comment

View of the tire tracks on the levee slope.

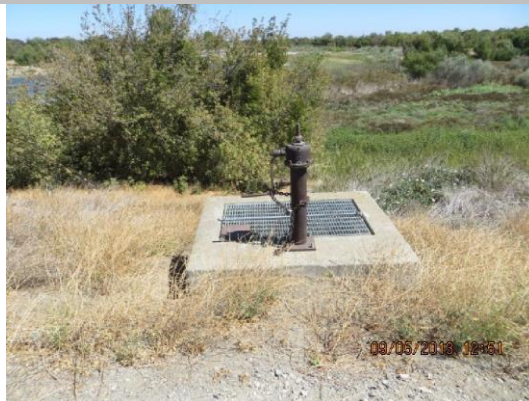
Photo 1 of 3 : UCIP_SP_2018_19436_32997.jpg

LM Start	3.80	Rating **	A/W	Issue No.	60
LM End	3.80	Issue Type +	Ma	Location *	
Category	Supplemental			GPS Latitude/Longitude	
				Start	End
Item	DWR UCIP LMA Responsibility			37.686976 °	37.686976 °
				-121.276838 °	-121.276838 °
DWR ID					
Comment Code					
Inspector Comment					
FS_ID:19436 DS_ID:20683 EP_NO: N/A Repair Type: No Action Needed Crossing Status: Found UCIP Comments: FIELD_STRUCT_DESC: 30-inch by 30-inch reinforced concrete box drainage culvert through the levee, 12 feet below the crown. Slide gate in concrete riser on the waterside (WS) slope. Concrete U-shaped headwalls on both ends. Flap gate on the WS end. Two concrete cutoff walls. [Additional Reference(s): DWR Levee Log, 2005. USACE San Joaquin O&M Manual 11, 1968, (HLM 3.71)]. FS Date: 9/5/2013 9:49:55 AM

Slide gate in Concrete riser on WS shoulder.

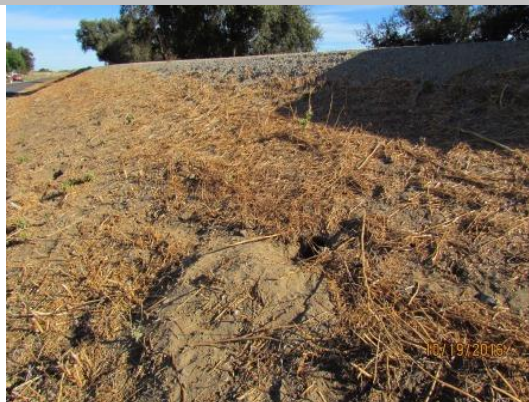
Photo 1 of 1 : SP_2018_RD2085_113_36_20180305_00027.jpg

LM Start	3.86	Rating **	A/W	Issue No.	36
LM End	3.91	Issue Type +	Ma	Location *	LS
Category	Earthen Levee			GPS Latitude/Longitude	
				Start	End
Item	Animal Control			37.686059 °	37.685340 °
				-121.276745 °	-121.276594 °
DWR ID	DWR_RD2085_01_f_2016_36				
Comment Code					
A3 : No rodents visible, but rodent burrows visible; need to backfill and compact or grout burrows.					
Inspector Comment					
Area should be monitored for possible rodent activity.

View of the rodent holes on the levee slope.

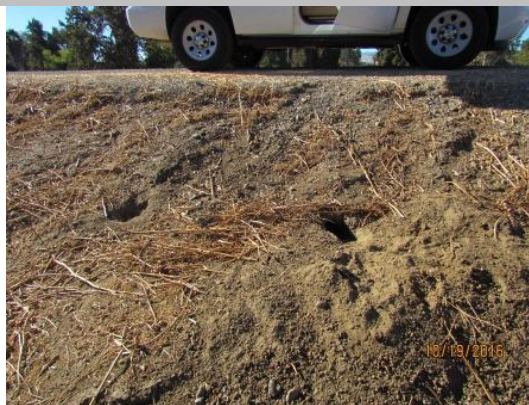
Photo 1 of 1 : SP_2018_RD2085_113_34_20180305_00026.jpg

LM Start	4.15	Rating **	A/W	Issue No.	34
LM End	4.15	Issue Type +	Ma	Location *	WS
Category	Earthen Levee			GPS Latitude/Longitude	
				Start	End
Item	Animal Control			37.682495 °	37.682495 °
				-121.274169 °	-121.274169 °
DWR ID	DWR_RD2085_01_f_2016_34				
Comment Code					
A3 : No rodents visible, but rodent burrows visible; need to backfill and compact or grout burrows.					
Inspector Comment					
Rodent holes were repaired and the area should be monitored for possible rodent activity.

View of the rodent holes on the levee slope.

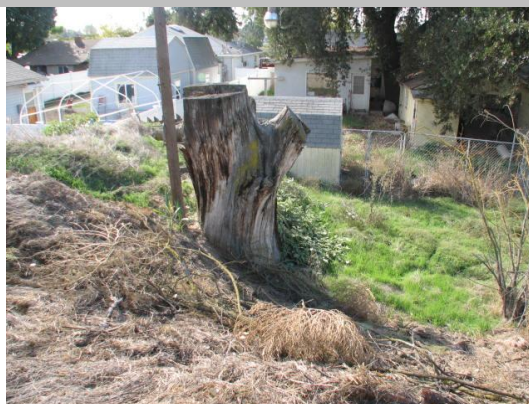
Photo 1 of 1 : SP_2018_RD2085_113_32_20180305_00023.jpg

LM Start	4.46	Rating **	N	Issue No.	32
LM End	4.46	Issue Type +	Ma	Location *	LS
Category	Earthen Levee			GPS Latitude/Longitude	
				Start	End
Item	Trim / Thin Trees			37.681605 °	37.681605 °
				-121.268882 °	-121.268882 °
DWR ID	DWR_RD2085_01_s_2012_32				
Comment Code					
T5 : Tree stumps.					
Inspector Comment

11/03/2011 Large stump on landside slope.

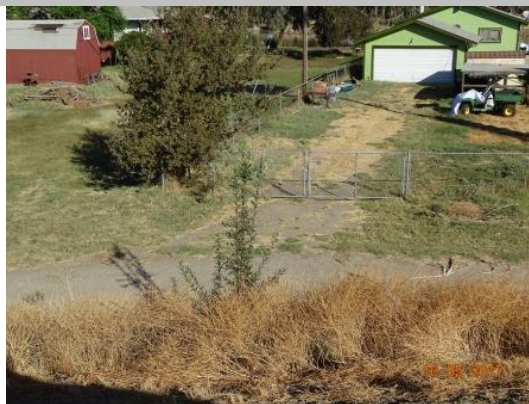
Photo 1 of 1 : SP_2018_RD2085_113_3_20180305_00009.jpg

LM Start	5.04	Rating **	A/W	Issue No.	3
LM End	5.04	Issue Type +	Ma	Location *	LS
Category	Earthen Levee			GPS Latitude/Longitude	
				Start	End
Item	Vegetation			37.677735 °	37.677735 °
				-121.269132 °	-121.269132 °
DWR ID	DWR_RD2085_01_f_2017_3				
Comment Code					
V7 : Trees / Woody Vegetation					
Inspector Comment					
Recommend removing volunteer tree.

View of the volunteer tree at the levee toe.

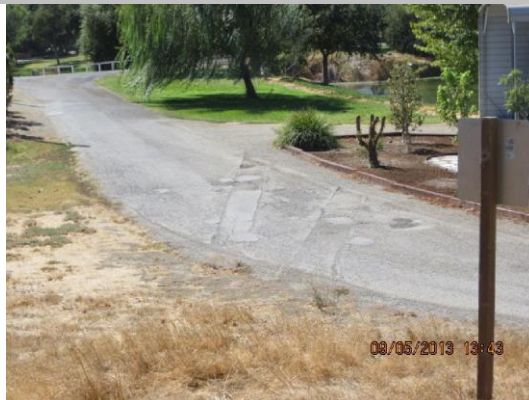
Photo 1 of 3 : UCIP_SP_2018_23060_39184.jpg

LM Start	5.22	Rating **	A/W	Issue No.	62
LM End	5.22	Issue Type +	Ma	Location *	
Category	Supplemental			GPS Latitude/Longitude	
				Start	End
Item	DWR UCIP LMA Responsibility			37.675271 °	37.675271 °
				-121.269281 °	-121.269281 °
DWR ID					
Comment Code					
Inspector Comment					
FS_ID:23060					
DS_ID:20686					
EP_NO: N/A					
Repair Type: No Action Needed					
Crossing Status: Found					
UCIP Comments:					
FIELD_STRUCT_DESC: 30-inch reinforced concrete drainage pipe through the levee, 10 feet below the crown. Concrete U-shaped headwall on the waterside (WS) end. Two corrugated metal cutoff walls. Flap gate on the WS end. [Additional Reference(s): DWR Levee Log, 2005. USACE San Joaquin O&M Manual 11, 1968, (HLM 5.12)].					
FS Date: 9/5/2013

Cuts in pavement off LS toe good indicator of pipe location.

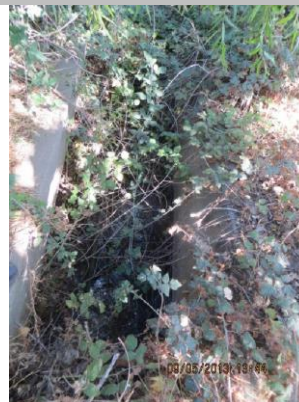
Photo 2 of 3 : UCIP_SP_2018_23060_39183.jpg

Concrete U-shaped headwall visible on WS toe.

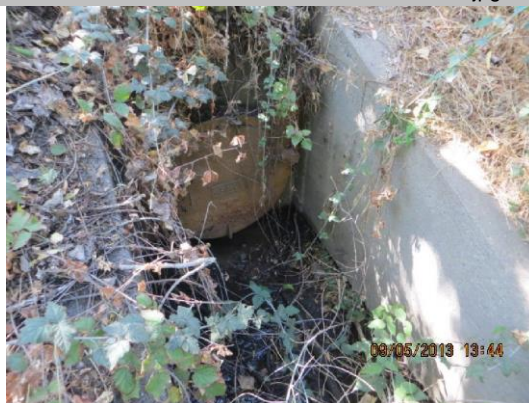
Photo 3 of 3 : UCIP_SP_2018_23060_39182.jpg

Concrete U-shaped headwall and flapgate visible on WS toe.

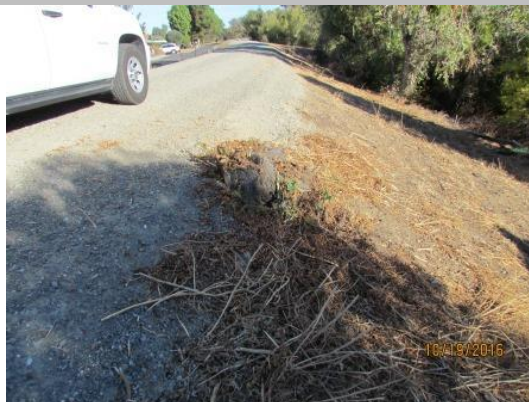
Photo 1 of 1 : SP_2018_RD2085_113_29_20180305_00022.jpg

LM Start	5.24	Rating **	N	Issue No.	29
LM End	5.24	Issue Type +	Ma	Location *	WS
Category	Earthen Levee			GPS Latitude/Longitude	
				Start	End
Item	Trim / Thin Trees			37.675099 °	37.675099 °
				-121.269264 °	-121.269264 °
DWR ID	DWR_RD2085_01_f_2015_29				
Comment Code					
T5 : Tree stumps.					
Inspector Comment

View of the tree stump.

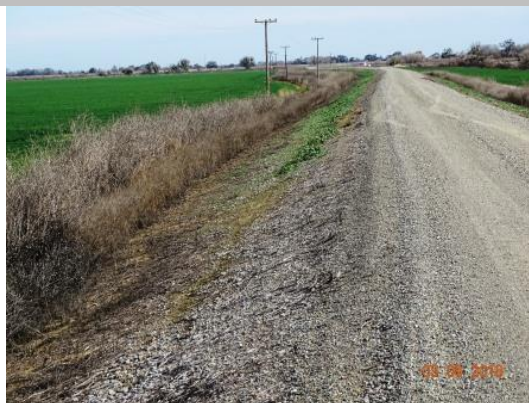
Photo 1 of 1 : SP_2018_RD2085_114_1_20180309_00001.jpg

View of the acceptable vegetation on the levee slope.

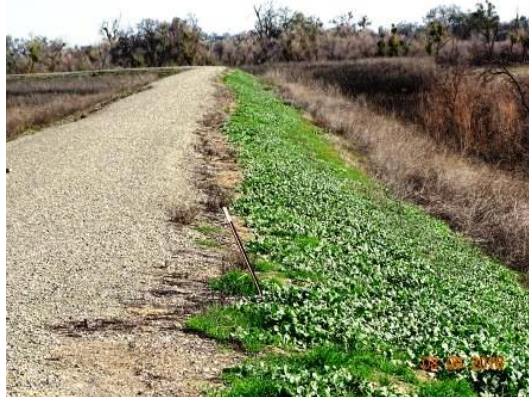
Photo 1 of 1 : SP_2018_RD2085_115_2_20180309_00004.jpg

View of the acceptable vegetation on the levee slope.

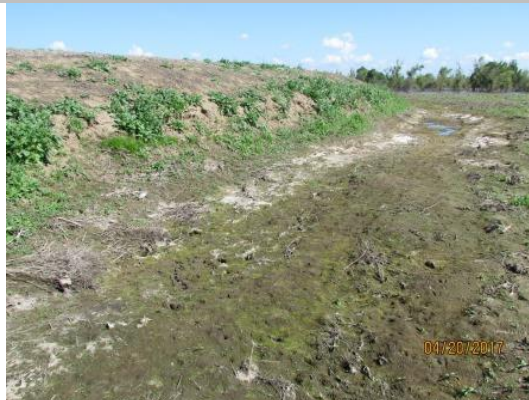
Photo 1 of 3 : SP_2018_RD2085_115_1_20180305_00001.jpg

LM Start	0.21	Rating **	U	Issue No.	1
LM End	0.23	Issue Type +	Ma	Location *	WS
Category	Earthen Levee			GPS Latitude/Longitude	
				Start	End
Item	Erosion / Bank Caving			37.682798 °	37.683052 °
				-121.262059 °	-121.261851 °
DWR ID	DWR_RD2085_03_s_2014_1				
Comment Code					
E2 : Schedule repair of erosion site prior to the next inspection.					
Inspector Comment					
Erosion of the waterside levee slope has been observed. The erosion is about 3 feet tall vertical from the slope to the base of projected levee toe.

View of the erosion at the waterside levee toe. Spring 2017.

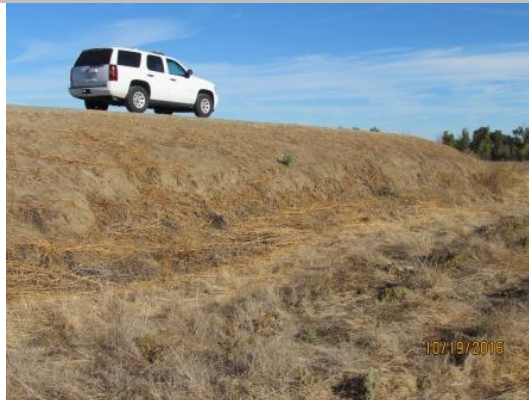
Photo 2 of 3 : SP_2018_RD2085_115_1_20180305_00002.jpg

View of the erosion at the waterside levee toe. Fall 2016.

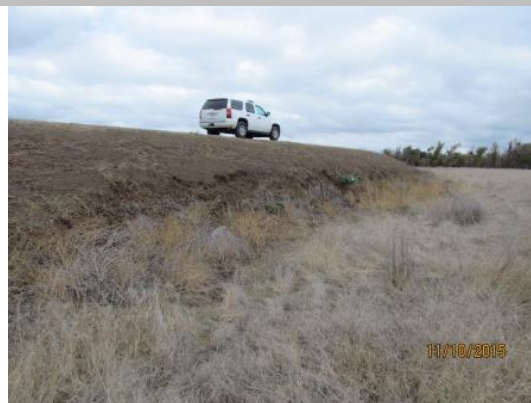
Photo 3 of 3 : SP_2018_RD2085_115_1_20180305_00003.jpg

View of the erosion at the waterside levee toe.
